les plages

FORMATI & SPESSORI
 SIZES & THICKNESS
 FORMATS & ÉPAISSEURS
 FORMATE & STÄRKEN

CARATTERISTICHE TECNICHE
 TECHNICAL FEATURES
 CARACTÉRISTIQUES TECHNIQUES
 TECHNISCHE EIGENSCHAFTEN

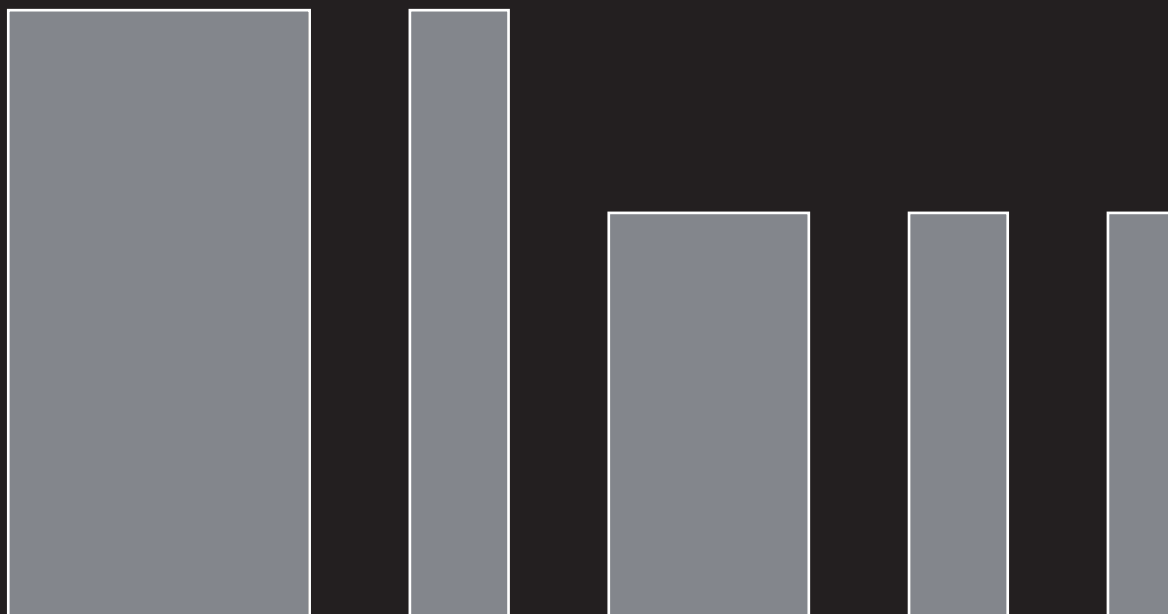
cm 45 x 90
 18" x 36"

cm 15 x 90
 6" x 36"

cm 30 x 60
 12" x 24"

cm 15 x 60
 6" x 24"

cm 10 x 60
 4" x 24"

Spessori
 Thickness
 Épaisseurs
 Stärken

mm 10,5

mm 9,5
